Is Revamping the Solution to Be at the Forefront of Innovation?

Antares Srl, San Martino Buon Albergo (VR), Italy ≥ info@antaresitaly.net

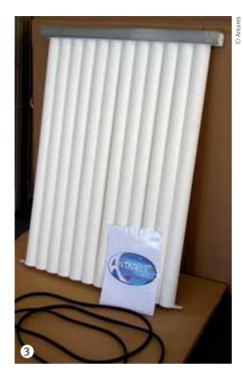
Figure 3: Air filtration units.

Antares' engineers intervened to resolve a dust leak problem on the air suction and filtration units downstream of the paint spray booths of a plant, which was due to a maintenance operation for the replacement of filters performed by a third party. The customer contacted the company after buying its filters but having relied on a neighbouring firm for their installation. It reported

a continuous leak of dust from the exhaust of the suction units. After several phone calls and e-mails to understand the problem and seek a solution, Antares decided to intervene

on site and solve the issue by disassembling and reassembling the filters (**Fig. 3**), also proving the technical preparation and experience of its engineers.
